## THESIS

**POWER PLANT AND  
DRIVE TRAIN IMPROVEMENTS  
OF THE  
NPS *HUMMINGBIRD*  
REMOTELY PILOTED HELICOPTER**

Robert E. Conway

September, 1996

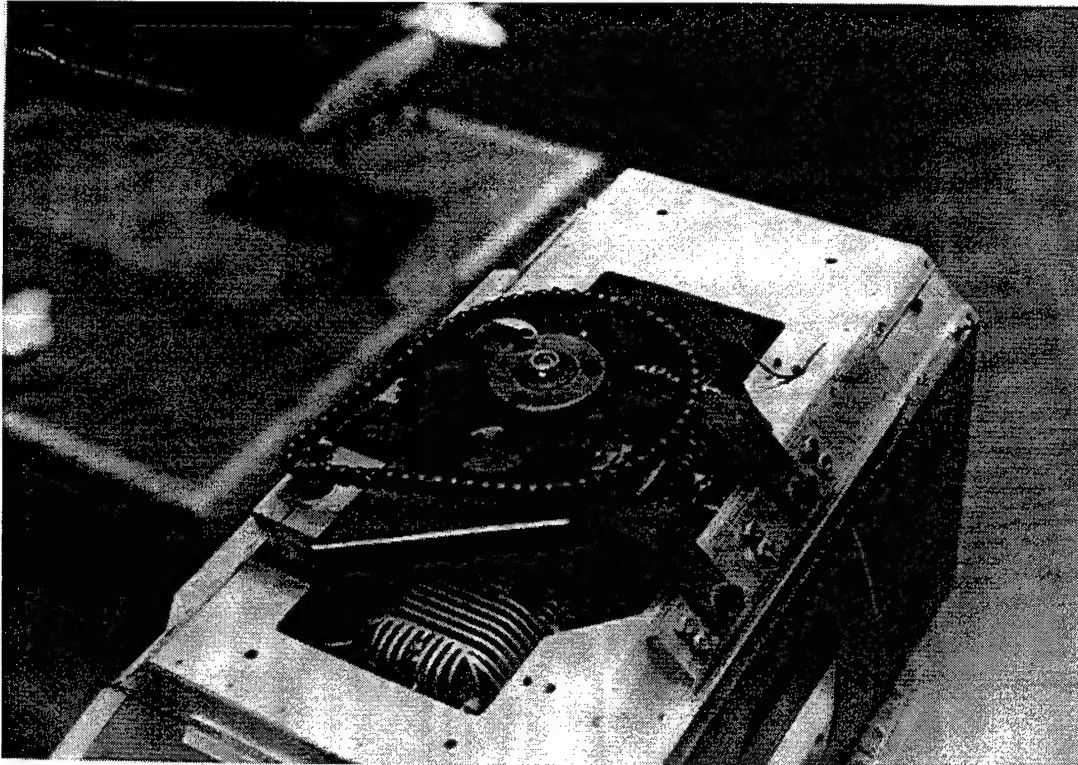
**Figure 1. Original Starting System Configuration**

The starter motor was found to be under powered. Prior starting attempts required two fully charged 12 volt marine batteries connected in series (24 volts total) for the electric motor to provide enough starting torque to the engine. This configuration ran the risk of burning out the starter motor and causing an electrical fire on the airframe.

Removal of the power cables risked entanglement of the cables in the main rotor system as the cables were free to whip as they were pulled from the fuselage. The main rotor arc extends 5 feet from the rotor hub and sits approximately 3 feet off the ground. Entanglement of the cables is an unnecessary risk to the program and a safety hazard.

Looking at its airflow obstruction effects and inability to perform reliably, it was decided to completely redesign the engine starting system. A major factor considered along with overcoming the existing deficiencies was the requirement to start the engine on the UAV test stand. Most UAV engines including the WAEL 342 in a fixed wing application need a counterclockwise torque for start. However, due to mounting constraints on this test stand, a starter must be able to provide starting torque in a clockwise direction as one faces the propeller. This demonstrated early on in the design that a starter capable of providing torque in both directions would be practical.

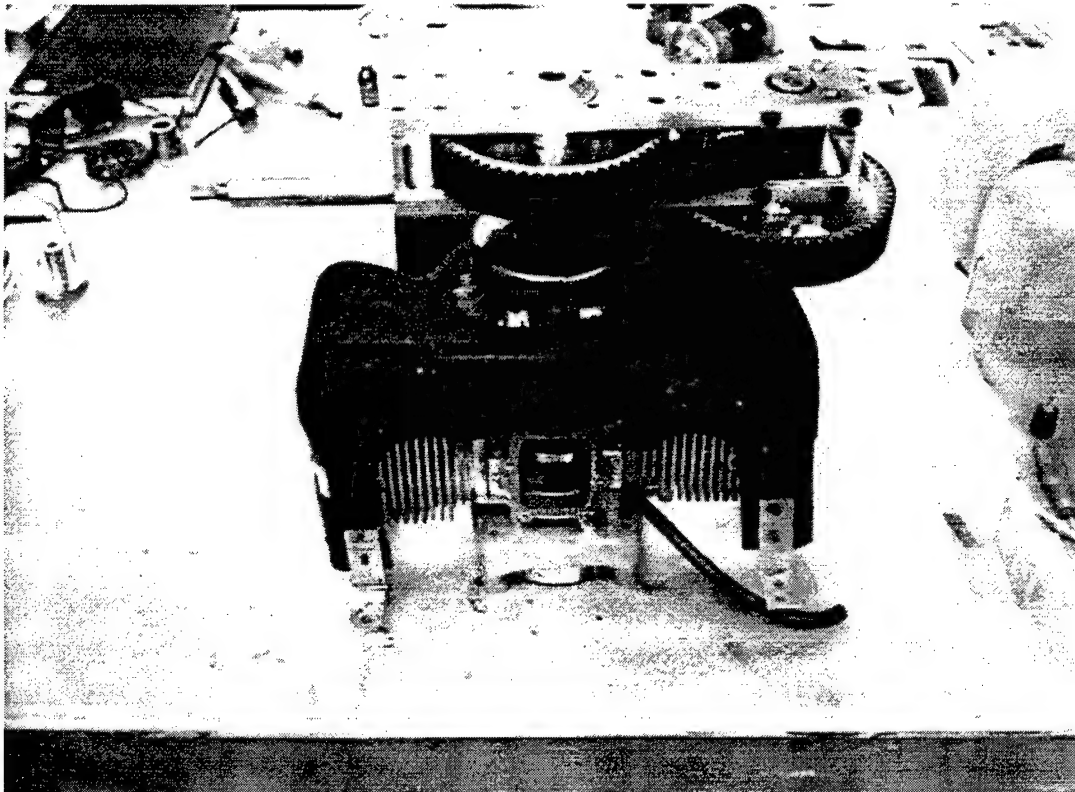
**Figure 2. Layout of Engine Cooling Components**

The original design of the *Hummingbird's* engine-cooling system was proven inadequate by failure of the engine due to overheating. The engine manual states that the maximum cylinder head temperature measured at the spark plug gasket is not to exceed 482° F and maximum exhaust gas temperature is not to exceed 1022° F. Upon inspection of the

failed engine, deep scoring was found in both cylinders. The pistons were locked into the cylinders and unable to be removed. Deposits of metal were also found fused to the cylinder walls pointing to a massive overtemp of the engine.

The engine cooling system was totally redesigned and modifications were made several engine components to accommodate the new system. Each deficiency listed in the engine cooling system deficiencies chapter was addressed and corrected resulting in a properly designed cooling system for the WAEL 342 engine's internal use.

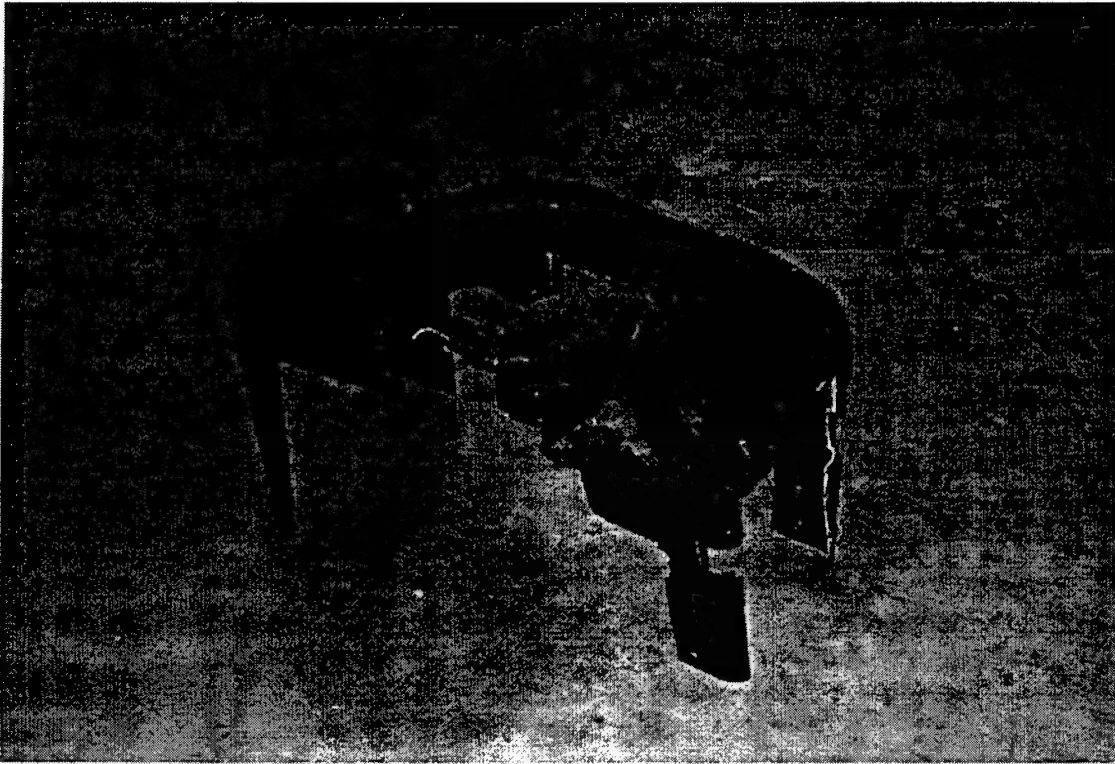
**Figure 3. Existing Engine Cooling Cowling**

The "cooling air-flow" was insufficient for the following reasons. First the cooling system was designed to draw air in to the center of the engine and then to direct it out along the cylinder. The cooling fins were perpendicular to the direction of flow causing the airflow to be disrupted as it moved further away from the center of the engine. Sufficient airflow to the cylinder head was therefore not available. A significant amount of the fiberglass cowling that directed the airflow over the engine had also been trimmed away to accommodate the starter and exhaust components. In order to mount the starter an approximately 3x5 inch square had to be removed. Other cut-outs for the engine exhaust, decompressors (small ports mounted on both cylinder barrels to aid in engine ignition) and mounting hardware, shown in Figure 3, had widdled away at the intended design rendering this component ineffective.

cooling air to flow more efficiently. The fiberglass cowling that previously directed the airflow over the cylinders and the vane-axial impeller was removed to accommodate a new air moving system and to further reduce the obstructions to the cooling air flow. Finally the original exhaust manifold and exhaust pipe were removed and replaced with two aluminum tube exhaust pipes that exhaust below the fuselage eliminating the undesirable heat source inside the fuselage.

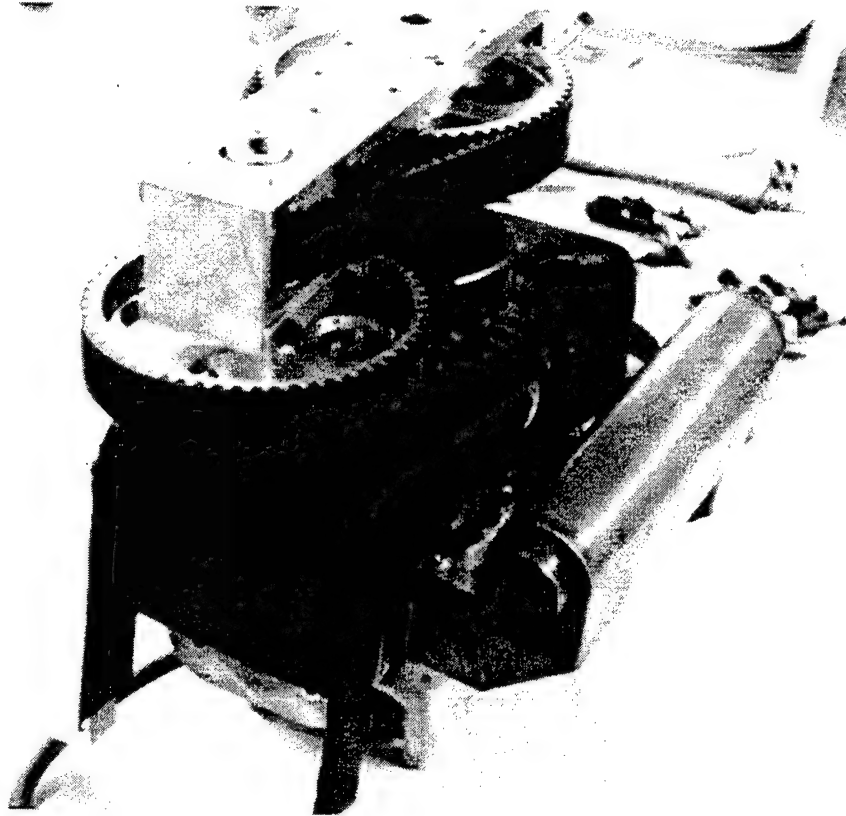
**Figure 4. Exhaust Manifold Position**

One of the main contributors to the cooling problem was the engine exhaust system. The exhaust system consisted of an exhaust manifold and a 12 inch long, 1 ½ inch diameter flexible steel tube. The manifold collected exhaust from both cylinders and provided limited noise muffling. The manifold is constructed of stainless steel with an attachment for the flexible tube in the rear. The tube ran from the manifold, around the rear of the engine and exited from the bottom of the fuselage. The maximum allowable cylinder head temperature is 482 °F and the maximum allowable exhaust gas temperature is 1022 °F. As will be discussed later, average observed exhaust gas temperature with proper fuel-air mixture is 600 °F to 700 °F. The manifold and exhaust pipe were radiating 600 °F to 700 °F over 182.7 square inches inside a mostly enclosed fuselage with virtually little outside air entering the

fuselage interior during ground runs aside from an insignificant amount of main rotor wash. The exhaust manifold was also positioned just 2 inches from the intake of the cooling fan as seen in figure 4.

The result was an intake of cooling air with an equal or higher temperature than the maximum cylinder head temperature.

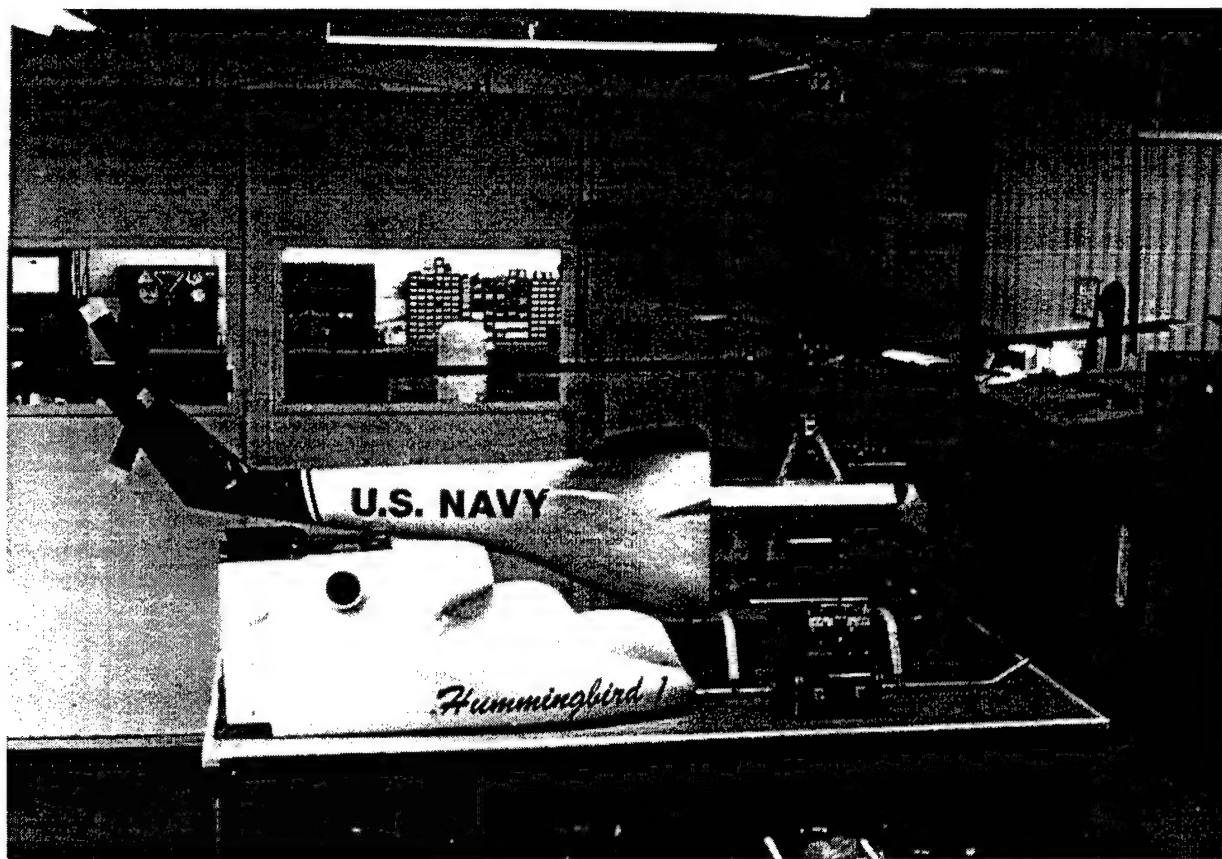
**Figure 5. Right Side View of *Hummingbird* Without Ventilation Port** body shell and the exhaust manifold's position just inside the fuselage. The solid fiberglass shell on right side allowed a build up of the exhaust manifold temperature which could have further increased the cooling air temperature at the intake of the cooling fan. The object seen in the hole in the fuselage in Figure 6 is the exhaust manifold.

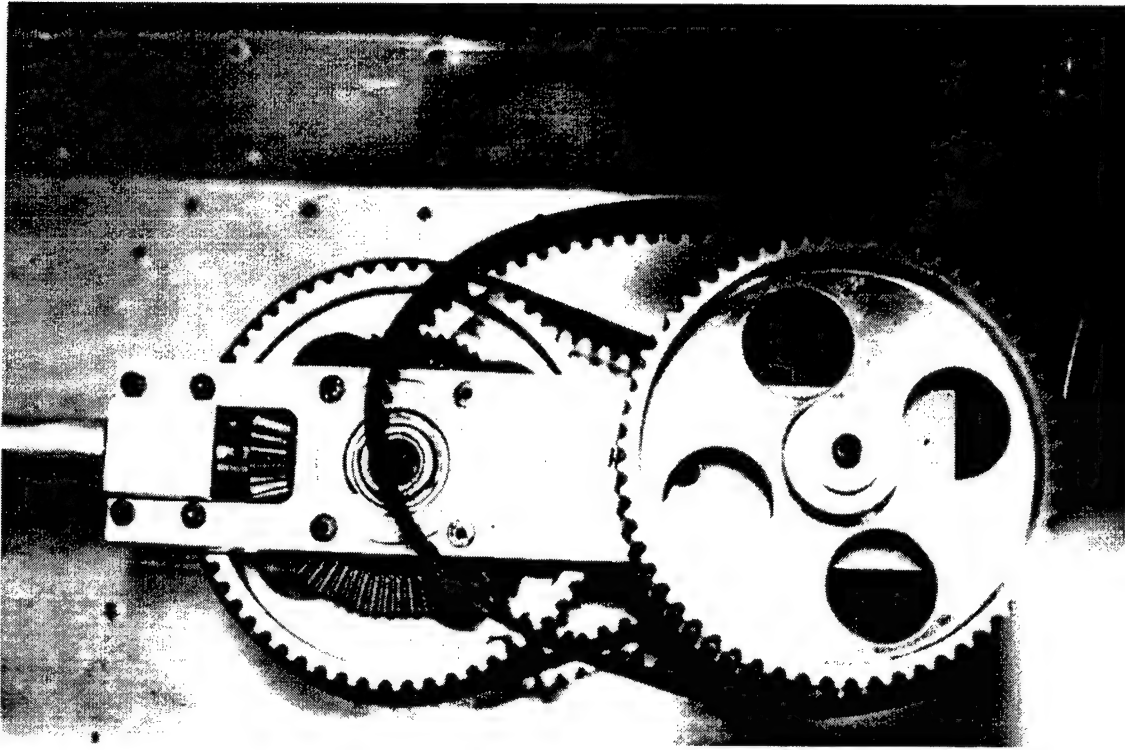
**Figure 6. Main Transmission**

As mentioned in the background investigation chapter, massive torque fluctuations due to unsteady idle speeds exist. These torque fluctuations were reported to, however unverified, snap the main rotor shaft of a similar RPH. In any case, fluctuations in engine torque are magnified ten times at the main rotor shaft due to the 10:1 mechanical advantage given by the transmission. With the exception of the hard rubber belts and limited slipping in the centrifugal coupling, there is nothing to absorb any sort of shock caused by torque

The intermediate shaft on the transmission shown in Figure 19 was selected as the location for the shock absorber assembly. The shock absorber itself is a Metalastik®

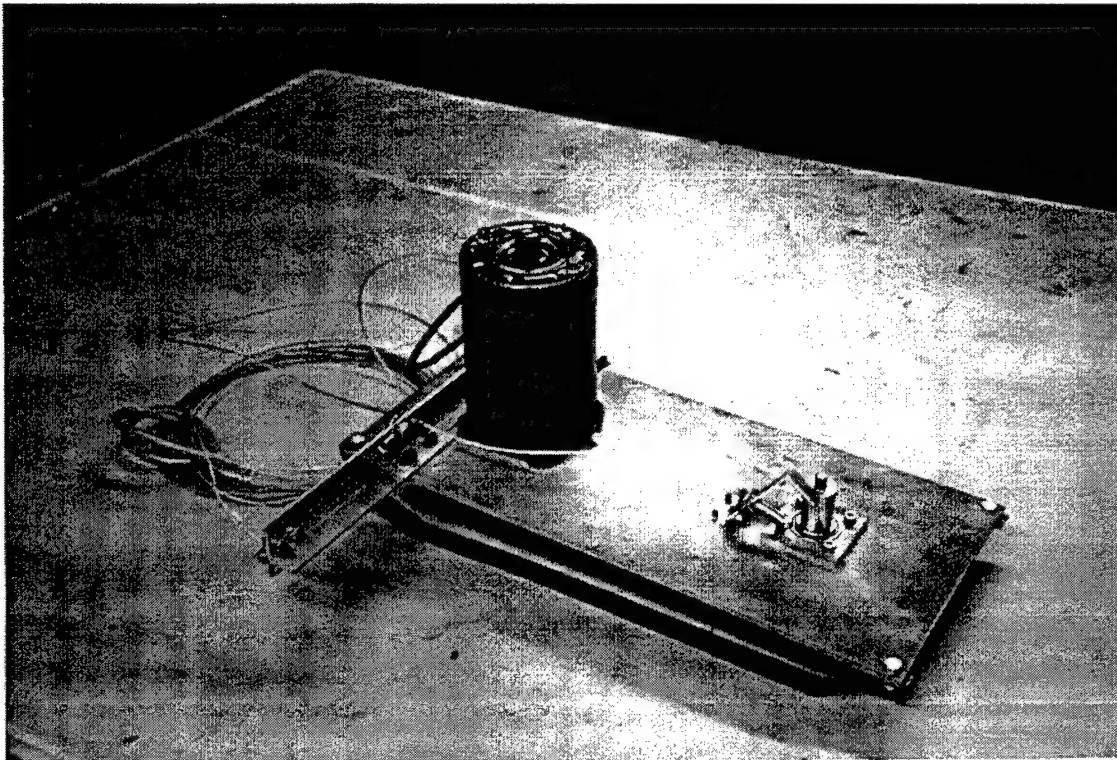
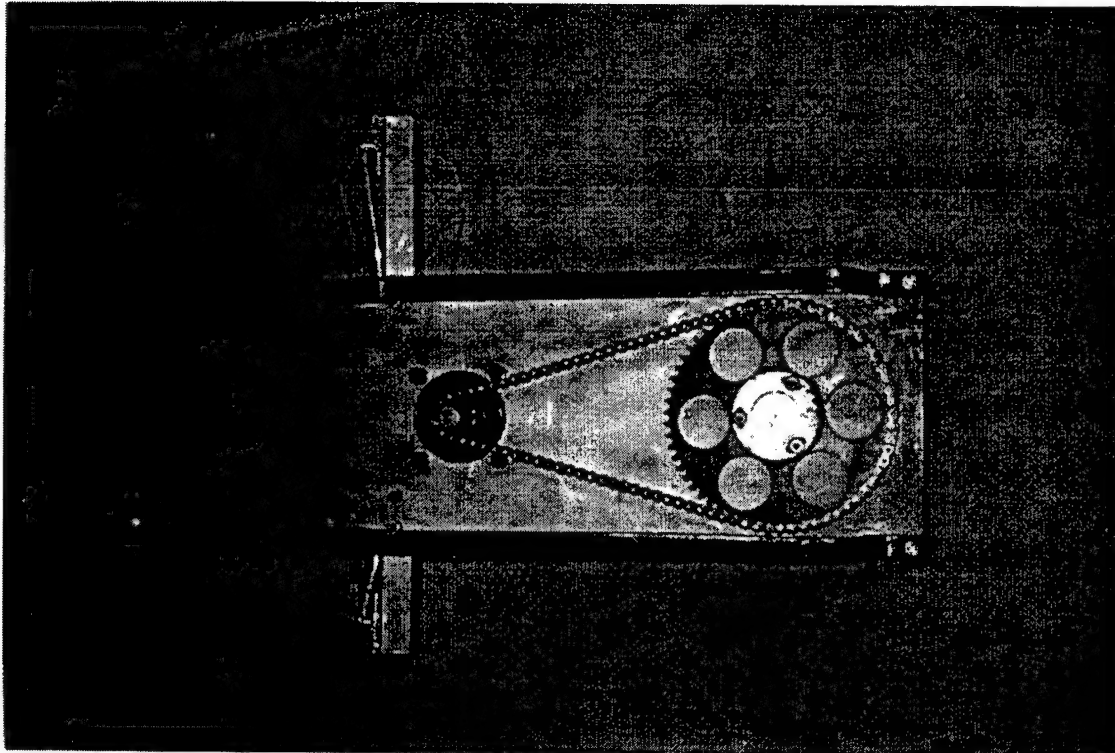
The starter assembly's final design is as shown in Figures 11 and 12. It consists of a 0.25" x 9" x 20" base plate to which the driving components are mounted. The starter motor is the 12 volt Prestolite MJB-4407 winch motor used in the hand held starter. A 1:1 drive ratio was proven effective by the hand held starter during the engine tests. Originally

the motor was mounted as follows. The starter motor mounts to the plate with the drive shaft passing through the plate from top to bottom. A 7 inch sprocket taken from the spare *Hummingbird* parts is mounted to the end of the shaft. An insert for the sprocket had to be designed and manufactured to replace a one-way bearing of the original design to eliminate any slippage. A chain drives another 7 inch sprocket which is mounted to the engine starting drive shaft. This sprocket contains a one way bearing which allows for torque application during start and freewheeling when the engine rpm exceeds the starter rpm. The original insert for the one way bearing was designed for the tapered shaft that mounted to the bottom of the engine by means of friction only which caused some damage due to metal-to-metal

slippage. A new piece was designed and manufactured to accommodate a straight shaft and key. The sprocket is attached to the drive shaft which passes upward through the plate. A 3/8 inch hex-ball drive wrench is pressed into an adapter which rides on a thrust bearing to prevent excessive wear of the starter drive shaft components. The ball drive wrench again gives the benefit of allowing small misalignments which occur during engine start and allows the starting assembly to drop free of the structure without jamming in the drive socket. The thin neck of the wrench is also the most convenient place for the starter to structurally fail should normal starting forces be exceeded.

Along with the above problem the starter had suffered minor damage. The head of the hex-ball drive snapped off twice during the engine start attempts. The design feature of structural failure location convenience was proven by this. During the repair of the hex-ball, minor damage to the insert of the 7 inch sprocket was discovered. The insert was peeked where the clutch mechanism engaged. The shallow depth deformations were found around its entire circumference. The design dimensions and material of the insert was copied exactly from the *hummingbird's* original starter with the only difference being a straight bore to fit the 0.75 inch starter motor shaft where the original design incorporated a tapered bore. The aircraft mounted starter insert showed no evidence of this damage.

The most probable cause for the starter damage and engine starting trouble is thought to be the following. Prior to the first wrench head failure a popping noise indicative of engine ignition was heard; however, ignition was not sustained. Disconnection of one spark plug could cause this. The sudden unloading and loading of the starter caused by the firing of one cylinder would cause the peeing and wrench head failure. Necessary corrections are currently underway to remedy the starter damage and spark plug cap problem. Further ground testing will be an area of future study.

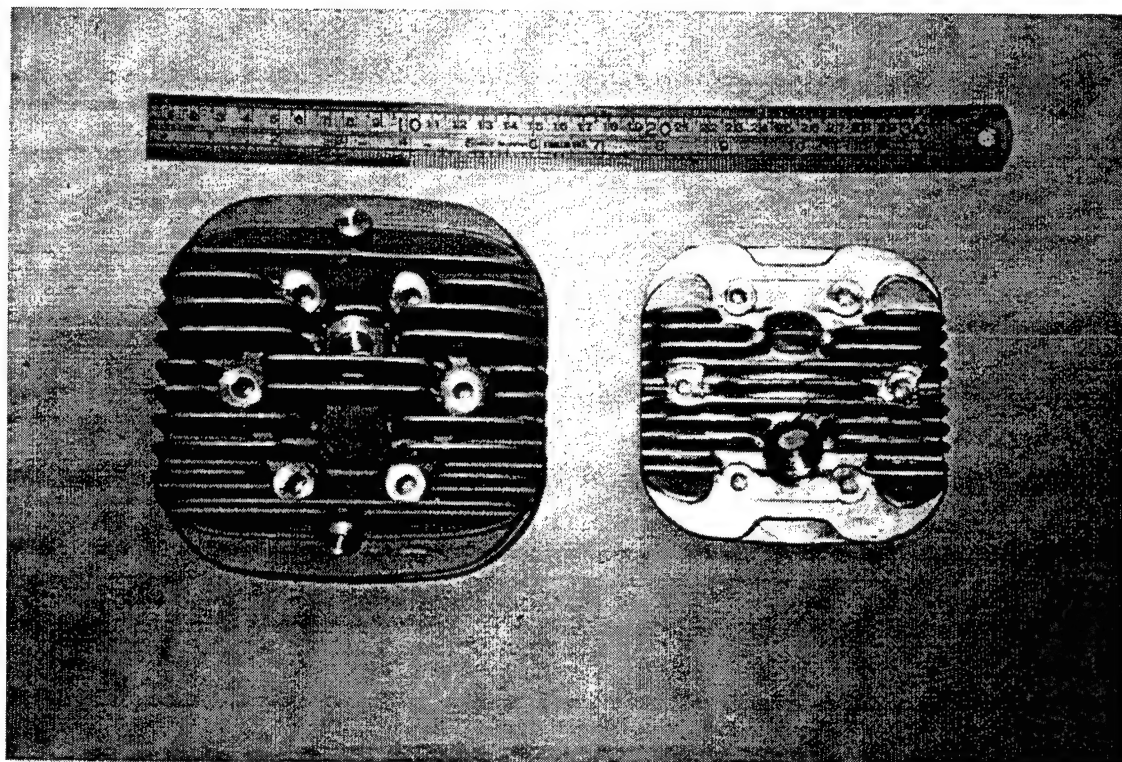
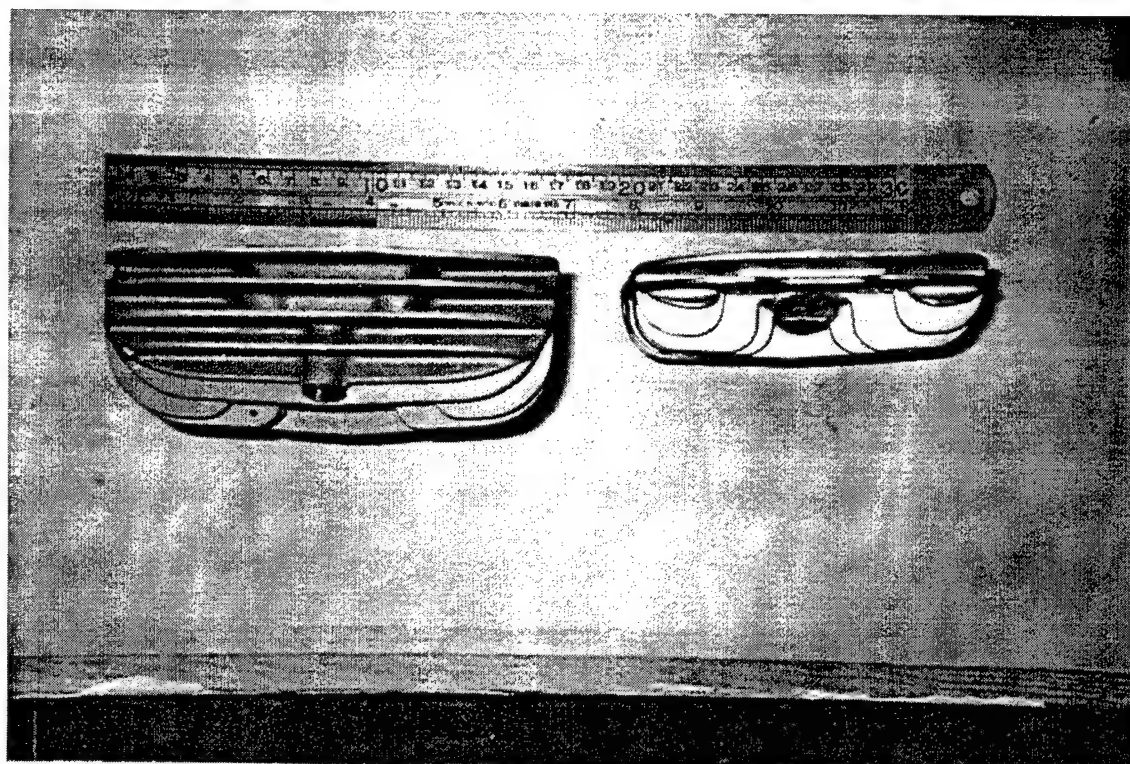
**Figure 15. Size Comparison of Cylinder Heads.**

As previously stated, the standard cylinder heads which was originally installed on the engine was replaced with the larger cylinder heads and are shown in comparison with each other in Figure 15. The effects of the improved heat dissipation through the significant increase in surface area have already been discussed. The larger heads required a standard size spark plug rather than the short plug used in the standard head. The engine manual called for a Bosch W6 BC spark plug with a 12.7 mm reach. An equivalent substitute plug, Splitfire SF 412C, was used due to the unavailability of the Bosch plug. The Splitfire plug has a smooth ceramic insulator where as other spark plugs have ridged ones. The smoothness caused the spark plug cap to slide off and disconnect during engine operation. To remedy this problem, retaining clips were installed to prevent the caps from working loose.

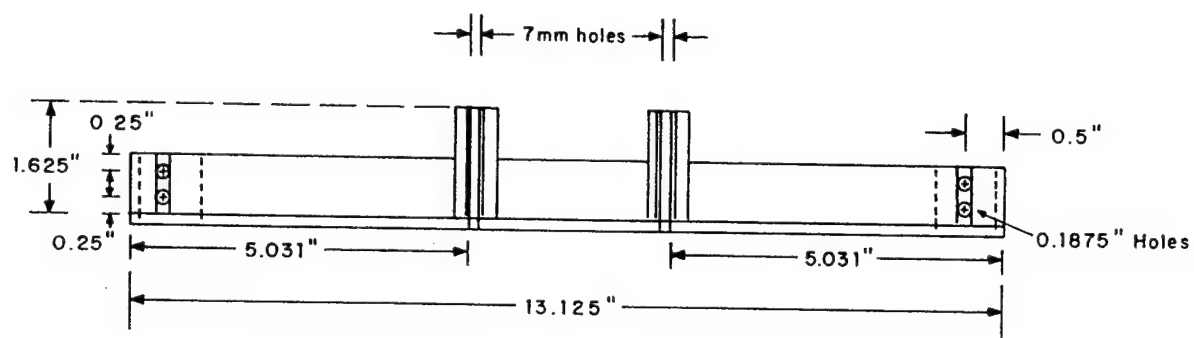
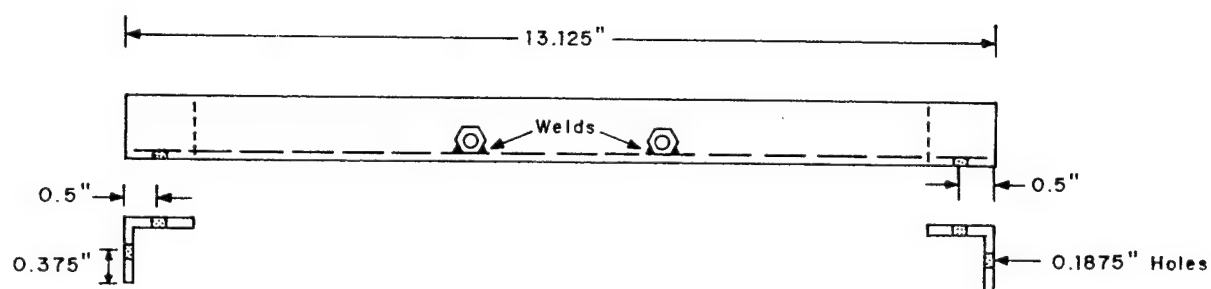
**Figure 16. Upper Engine Mount**

(1) Upper Engine Mount. As the engine required some minor modification on the test stand, the *Hummingbird* required some airframe modification to accommodate the new enlarged cylinder heads. The four engine mounting points on the bottom of the airframe remained unchanged; however, the upper engine mounting bracket that was installed as a part of LT Greg Fick's [ref. 3] modifications shown in Figure 16 had to be moved aft by at least 1.04 inches due to the difference in the cylinder head thicknesses. The two side stiffening plates were moved aft to provide the necessary airframe support for the bracket's new position.

The bracket modification led to another problem. The upper engine mount braced the engine through two of the six 6 mm cylinder head bolts. There existing cylinder head bolt was not long enough to provide support for the cylinder head and also pass through the upper engine mount. Attempts to find longer bolts and 6mm threaded rod failed as no local supplier carried the longer bolts or metric size threaded rod. As a result, two adapters which acted as a cylinder head bolt, spacer and upper engine mount attachment point were designed to custom fit this application. Figure 17 shows this piece. The cylinder head bolt segment is 6 mm in diameter and includes the correct cylinder head bolt thread length. The spacer was designed to provide a gap between the cylinder head and upper mount brace so there will be no damage inflicted on the cylinder head heat fins while the both the engine and airframe vibrate. The remainder consists of the mounting bracket threads which are also 6 mm in diameter.

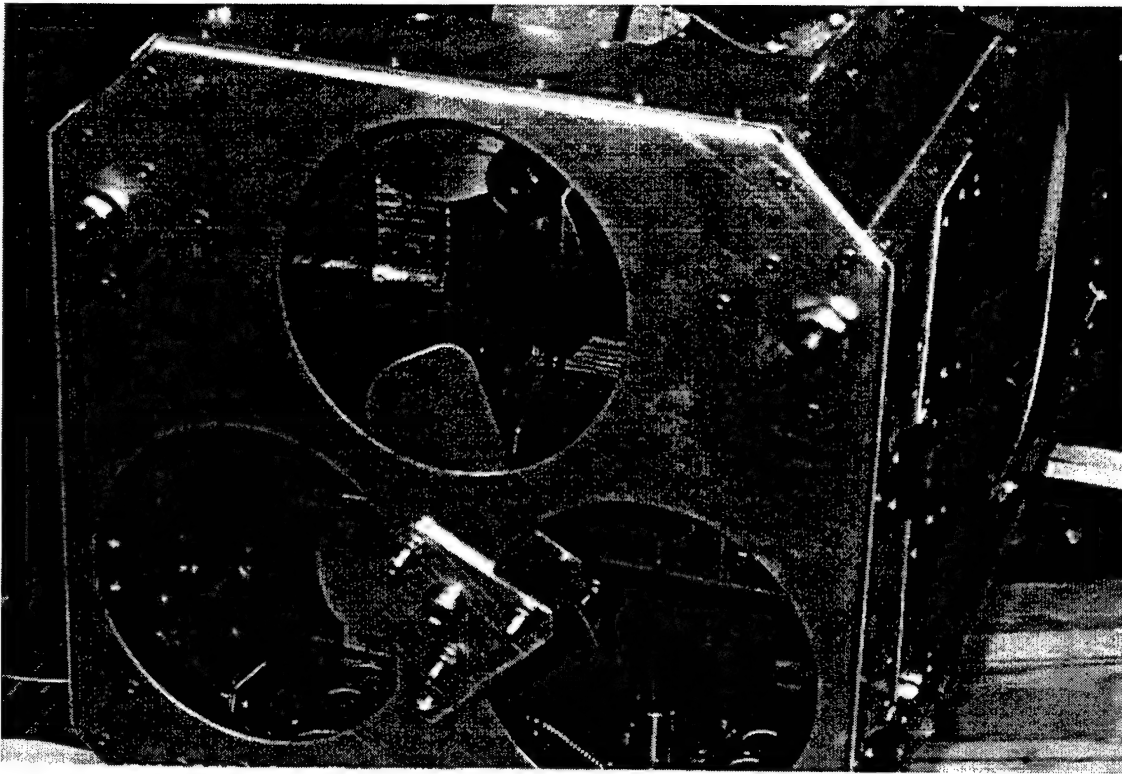
**Figure 18. Cooling Fan and Drive Configuration**

After considering many options of cooling fans, configurations and suggestions from industry, a simple and reliable design was implemented. The cooling air velocity through the engine compartment was observed during the engine tests and a system to move air through at this speed was introduced. Two air-conditioning condenser fans rated at 500 cfm at 3000 rpm were purchased for less than \$6.00 and mounted to ventilate the new 1.3 cubic foot engine compartment. One fan was modified to fit on the tail rotor drive take-off shaft off the main transmission which rotates at 40 percent of the engine rpm or 1200 to 2800 rpm. The other fan was mounted to the rear wall of the engine compartment. As shown in Figure 20, the lower fan is driven by a belt drive configuration and rotates at the same rpm as the tail rotor drive shaft. The tail rotor shaft mounted fan provides cooling air primarily to the forward cylinder while the belt driven fan provides ventilation to the aft cylinder.

Information on this fan was unavailable. Measurement of the cooling fan air flow at 1500 rpm (approximate fan rpm at engine idle) showed approximately 345 cfm. Assuming a linear increase in air flow with increasing rpm as seen in several other fan

performance charts, the air flow at 2800 rpm is estimated at 480 cfm. Thus the two fans together produce 960 cfm at 7000 engine rpm through the engine compartment which exceeds the air flow pattern seen on the engine test stand.

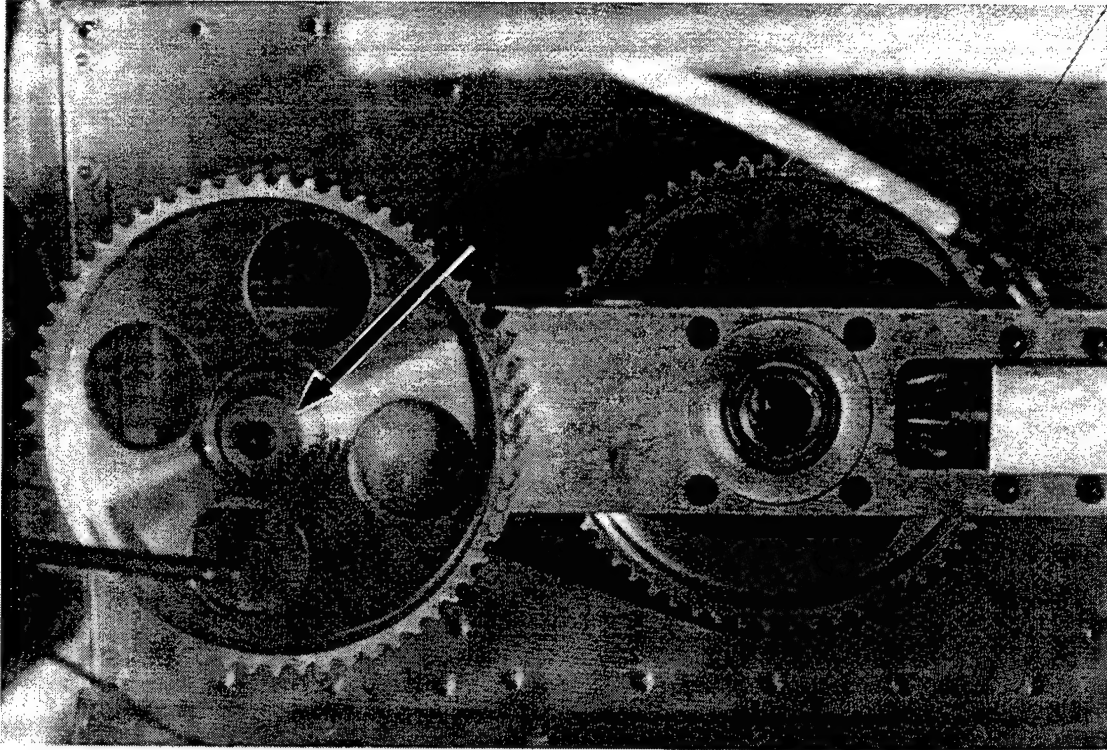
**Figure 19. Intermediate Shaft of the Main Transmission**

Rotoflex® coupling. It consists of a hexagon of rubber with six metal inserts bonded into position. It also contains metal interleaves bonded into the rubber for increased torque capacity when required. The coupling must be able to withstand a 76.8 ft-lb sustained load plus a 32 ft-lb impulse load totaling a maximum load of 108.8 ft-lbs. The 76.8 ft-lb moment was obtained by using the maximum torque rating of 24 ft-lbs and multiplied by 3.2 for the load at the intermediate shaft. . A coupling closest to this specification was ordered. This size coupling gives a safety margin of 1.33 computed for rated maximum torque to estimated
